Water Born Debris Removal Evaluations Using a Traveling Screen at the Tracy Fish Collection Facility, California

**Volume 33**

# Tracy Fish Facility Studies California

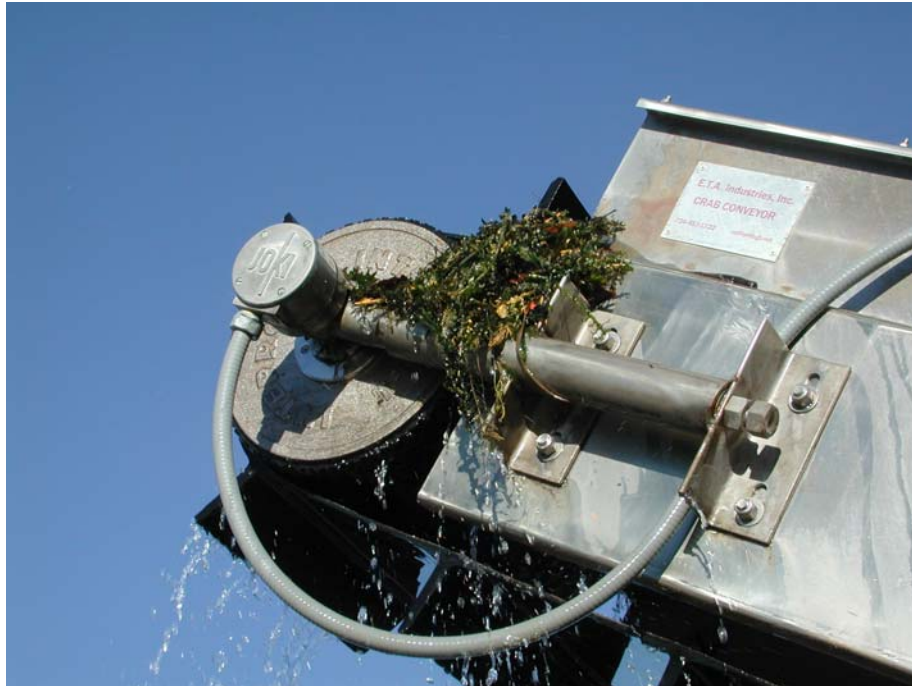
FIGURE 2a.—Before: Debris would fall off the sides of the conveyor or be blown away by the wind and therefore was not collected in the debris hauling truck.

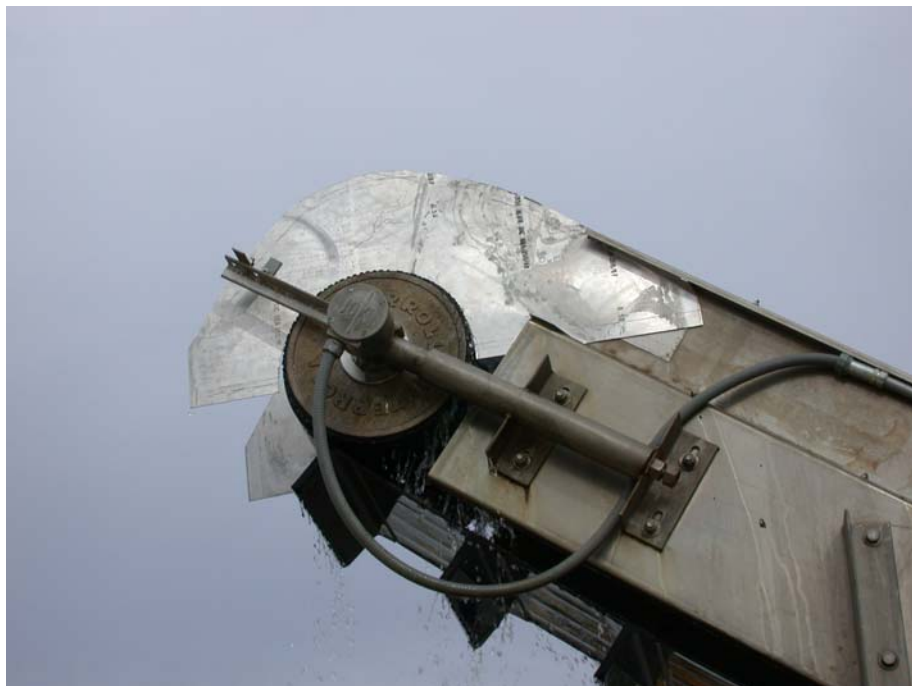
FIGURE 2b.—After: Sheet metal guides keep debris on conveyor to the end of the belt so that it is collected.

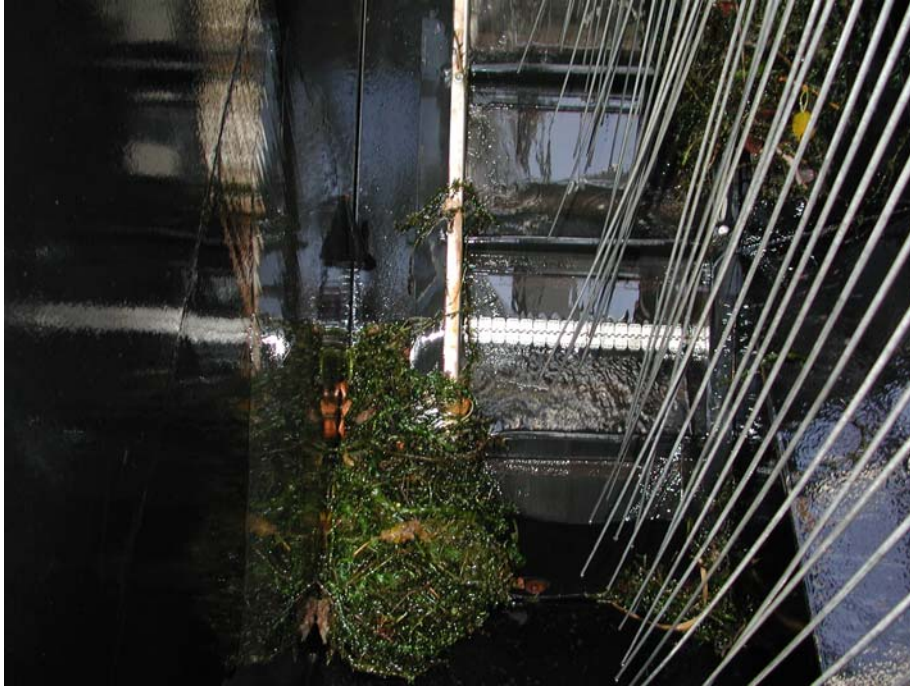
FIGURE 3a.—Before: At the back wall of the hopper (west ledge) debris too large to flow through the drain tube would accumulate at the base of the hopper.

- (2) Stainless steel punch plate, having a hole size of 3/32 inch (2.25 mm), was installed on the west (downstream side) wall of the hopper (July 2003). This prevented debris from collecting on the west ledge or within the gutter area, thereby, maintaining flow of excess water through the hopper drain tube. Before, the punch plate installation, debris would clog the drain tube within a few hours of operation (see figure 3a and 3b). Aluminum punch plate was first used to cover the gutter area and drain tube. However, this material was unsuitable because it was not as slick as stainless steel and plant material would tend to cling on the punch plate (July 2002). Also, the hole diameter was larger, approximately 1/8 inch (2.9 mm) allowing *Egeria* stems to catch in the holes and clog the surface of the punch plate.

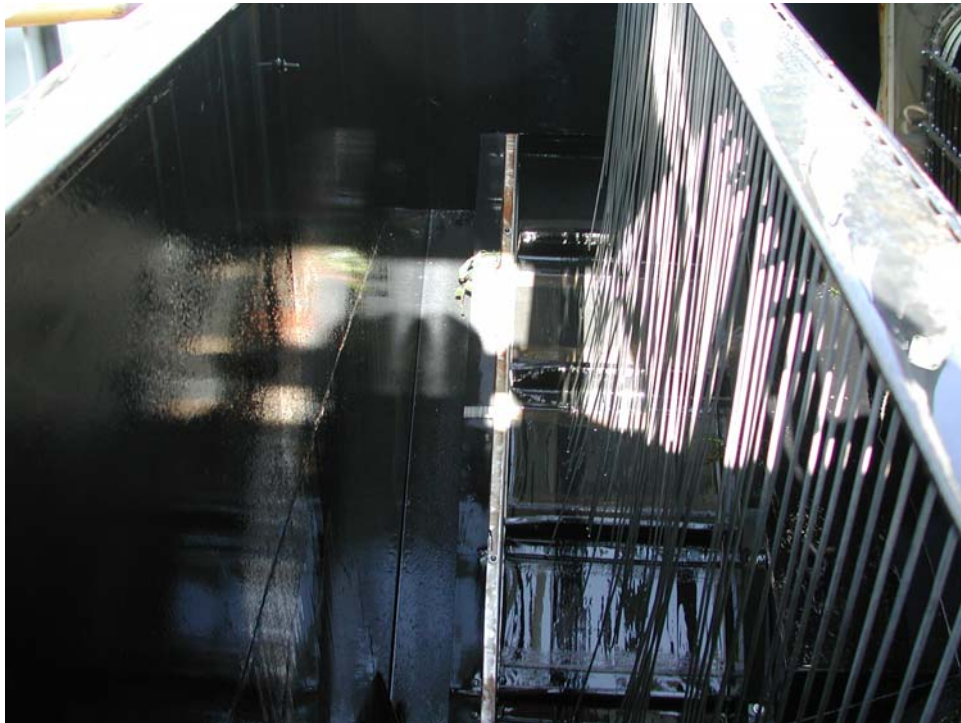
FIGURE 4.—The stainless steel tines were lowered further into the hopper and closer to the conveyor belt to intercept and drop more debris onto the conveyor.

- (3) The stainless steel tines intercept and drop much of the debris, sprayed off of the traveling screen, onto the conveyor. By lowering these tines further into the hopper, less debris passed under the tines, to the punch plate screen mounted on the back wall of the hopper (see figure 4). This was done in July of 2003. The same time the aluminum punch plate was replaced with stainless steel punch plate.

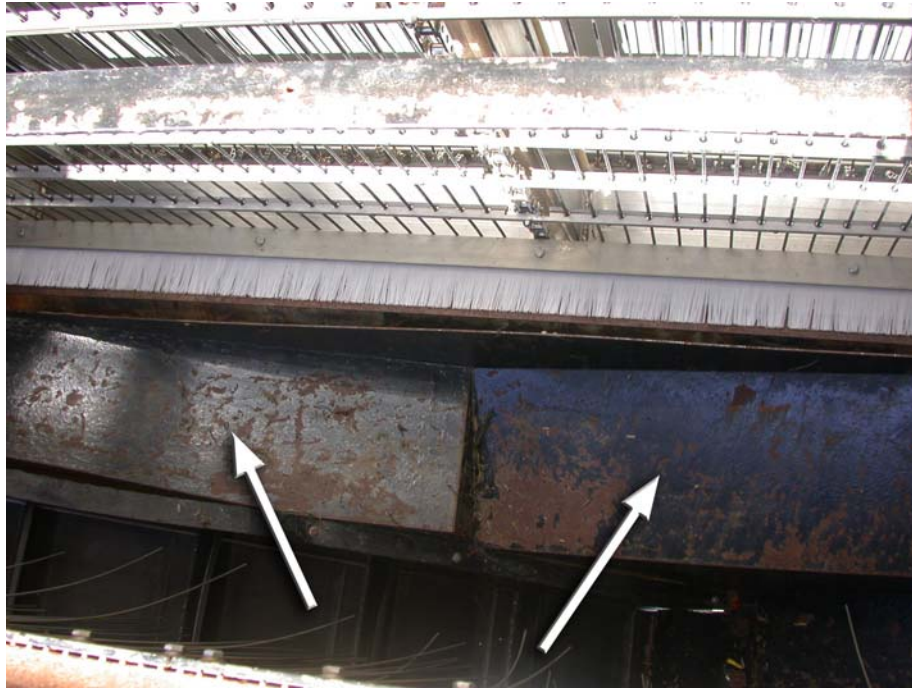
FIGURE 5a.—Before: Two, different angle, steel ledges, on the east side of the hopper (upstream side), collected much debris that the sprayers were unable to move onto the conveyor.

- (4) Within the hopper, on the east side (upstream direction) of the conveyor, there were two steel ledges that met approximately in the middle of the hopper. These two ledges met at differing heights and therefore, did not deliver aquatic vegetation, crabs, woody debris, and other material to the conveyor effectively. The shallow sloped ledge was cut and sloped more steeply to match the slope of the other ledge, thereby forming a single ledge, improving the flushing of debris off this ledge and into the hopper (July 2003). This new ledge was then covered in stainless steel providing a slicker surface to help slide debris onto the conveyor (see figure 5a and 5b).

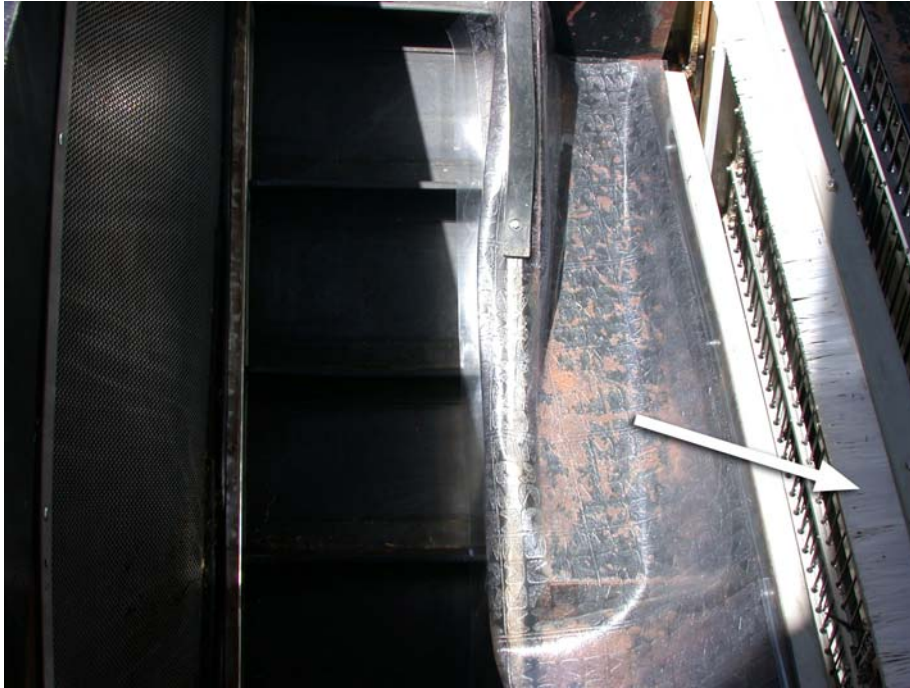
FIGURE 7.—Additional lifts were added to the traveling screen to help collect more debris.

- (6) Extra lifts were added to the traveling screen, increasing the number of lifts from 8 to 12, in the spring of 2004 (see figure 7).
- (7) A stainless steel tray was built and attached below the hopper, conveyor, and a portion of the traveling screen (spring and summer, 2004). This was done to catch debris that failed to fall into the hopper or was back flushed off the bottom of the conveyor. This material was previously lost back into the secondary channel after being collected by the traveling screen. The tray is sloped to one corner where the debris is flushed with excess water, from the conveyor and hopper, into a sluice box which delivers the debris to a basket, a secondary debris collection point (see figure 8).
